(9) BUREAU OF SHIPS GROUP
TECHNICAL INSPECTION REPORT

(6) OPERATION CROSSROADS,
BEACHED LANDING CRAFT,

TEST BAKER

OPERATION CROSSROADS

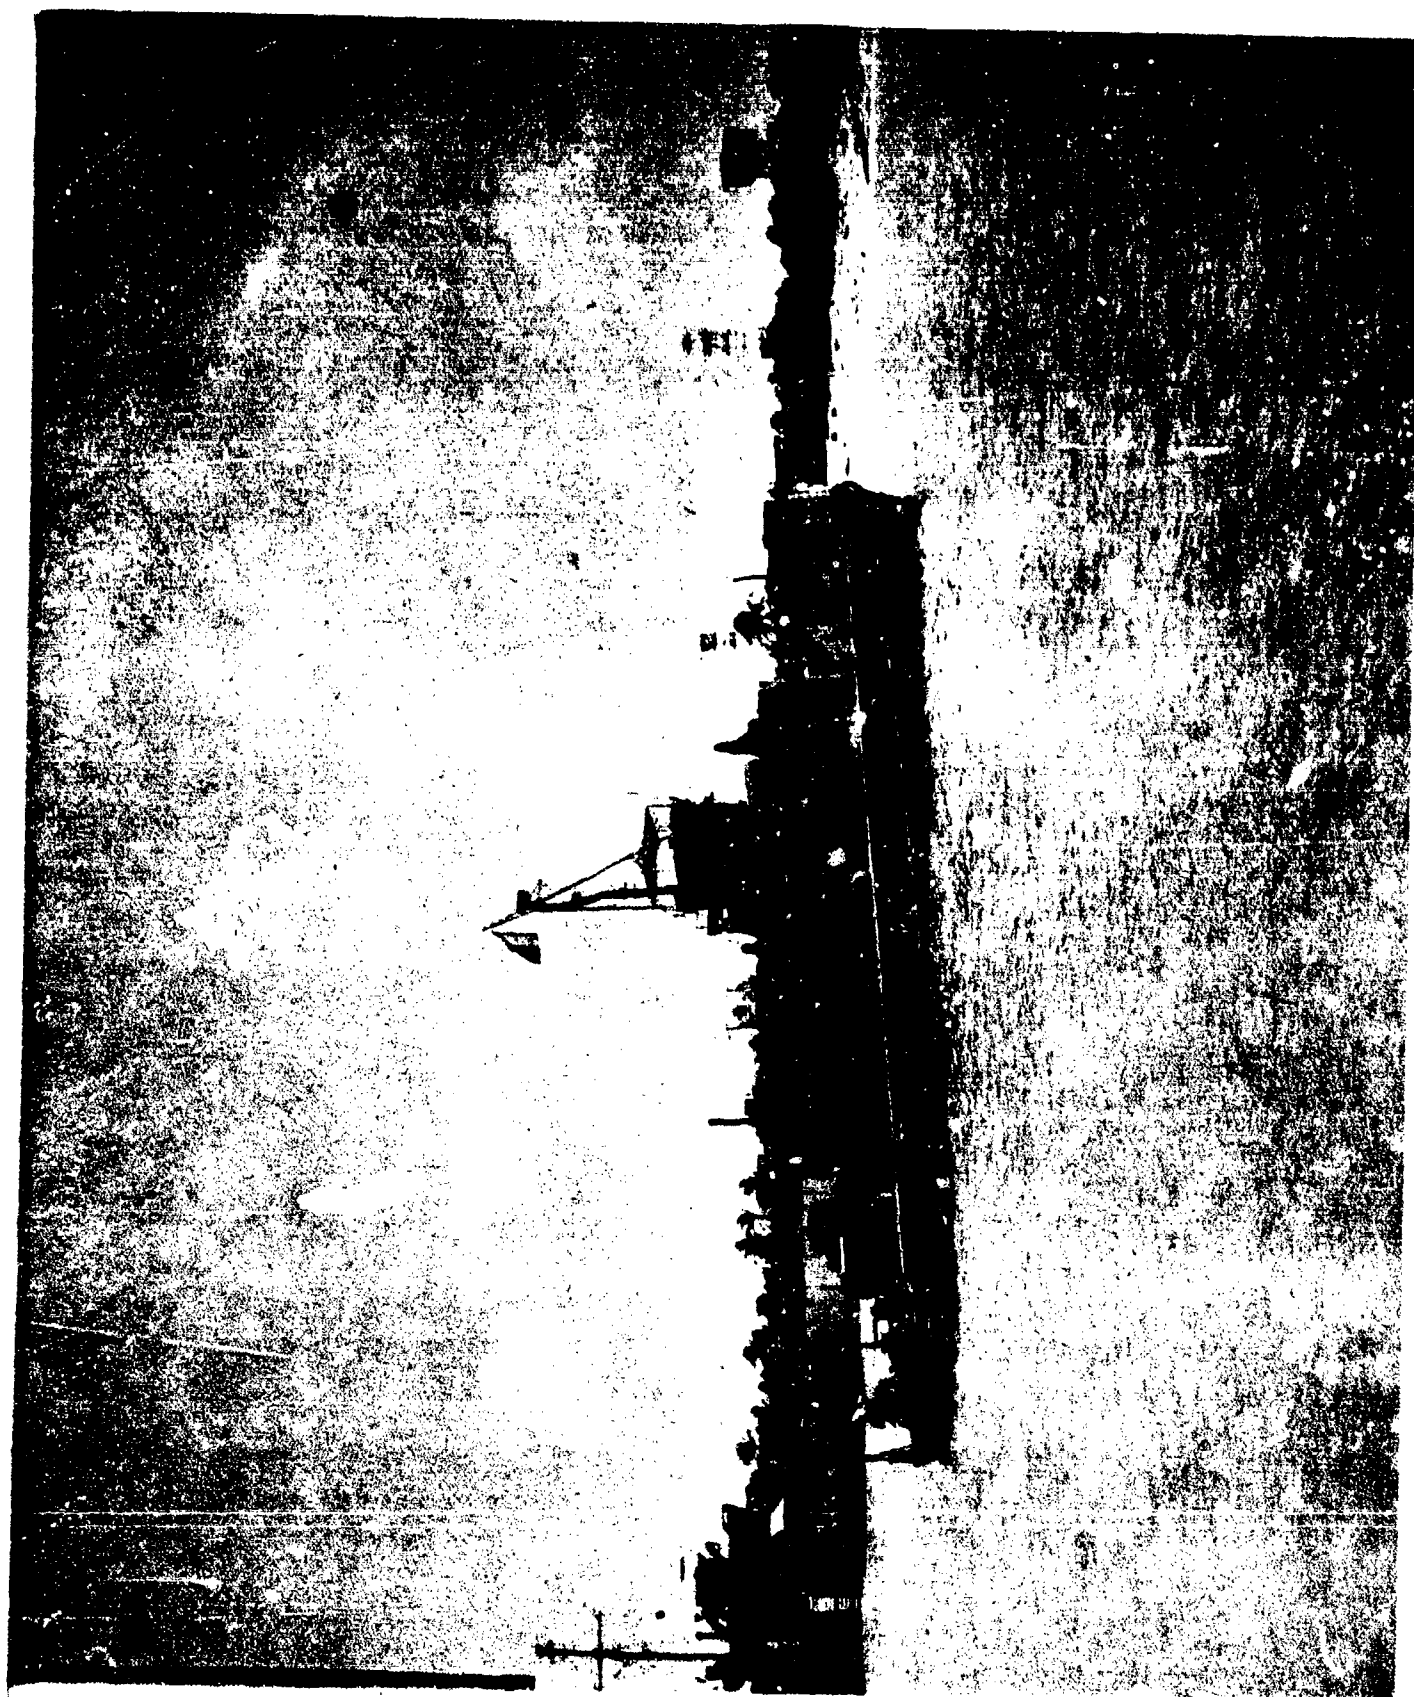
AB-CR-199-1502-5. LCI-620 after Test B.

This vessel was beached prior to the test. (Photograph 502-13, page 16). A photograph taken soon after test B shows the vessel afloat, subject to the restraint of the stern anchor, indicating that the wave which followed the test caused the vessel to become waterborne. The vessel was afloat at the time of inspection. (Photographs 292-32, page 21 and 1502-5, page 27). Flooding indicates bottom damage due to striking against coral. A part of this damage probably is a result of the test B water wave, aggravated by prior contact with coral. This vessel had been beached in the vicinity of coral ledges continuously for a period of one month.

The engine room was flooded to within 4-1/2 feet from the overhead, submerging all engines and generators, and about two-thirds of the switchboards. The steering gear compartment was flooded to a depth of 18 inches. The after troop compartments contained approximately five feet of water.

The starboard ramp was ripped off the ship and all loose gear on the fantail was found piled up against the after end of the deck house.

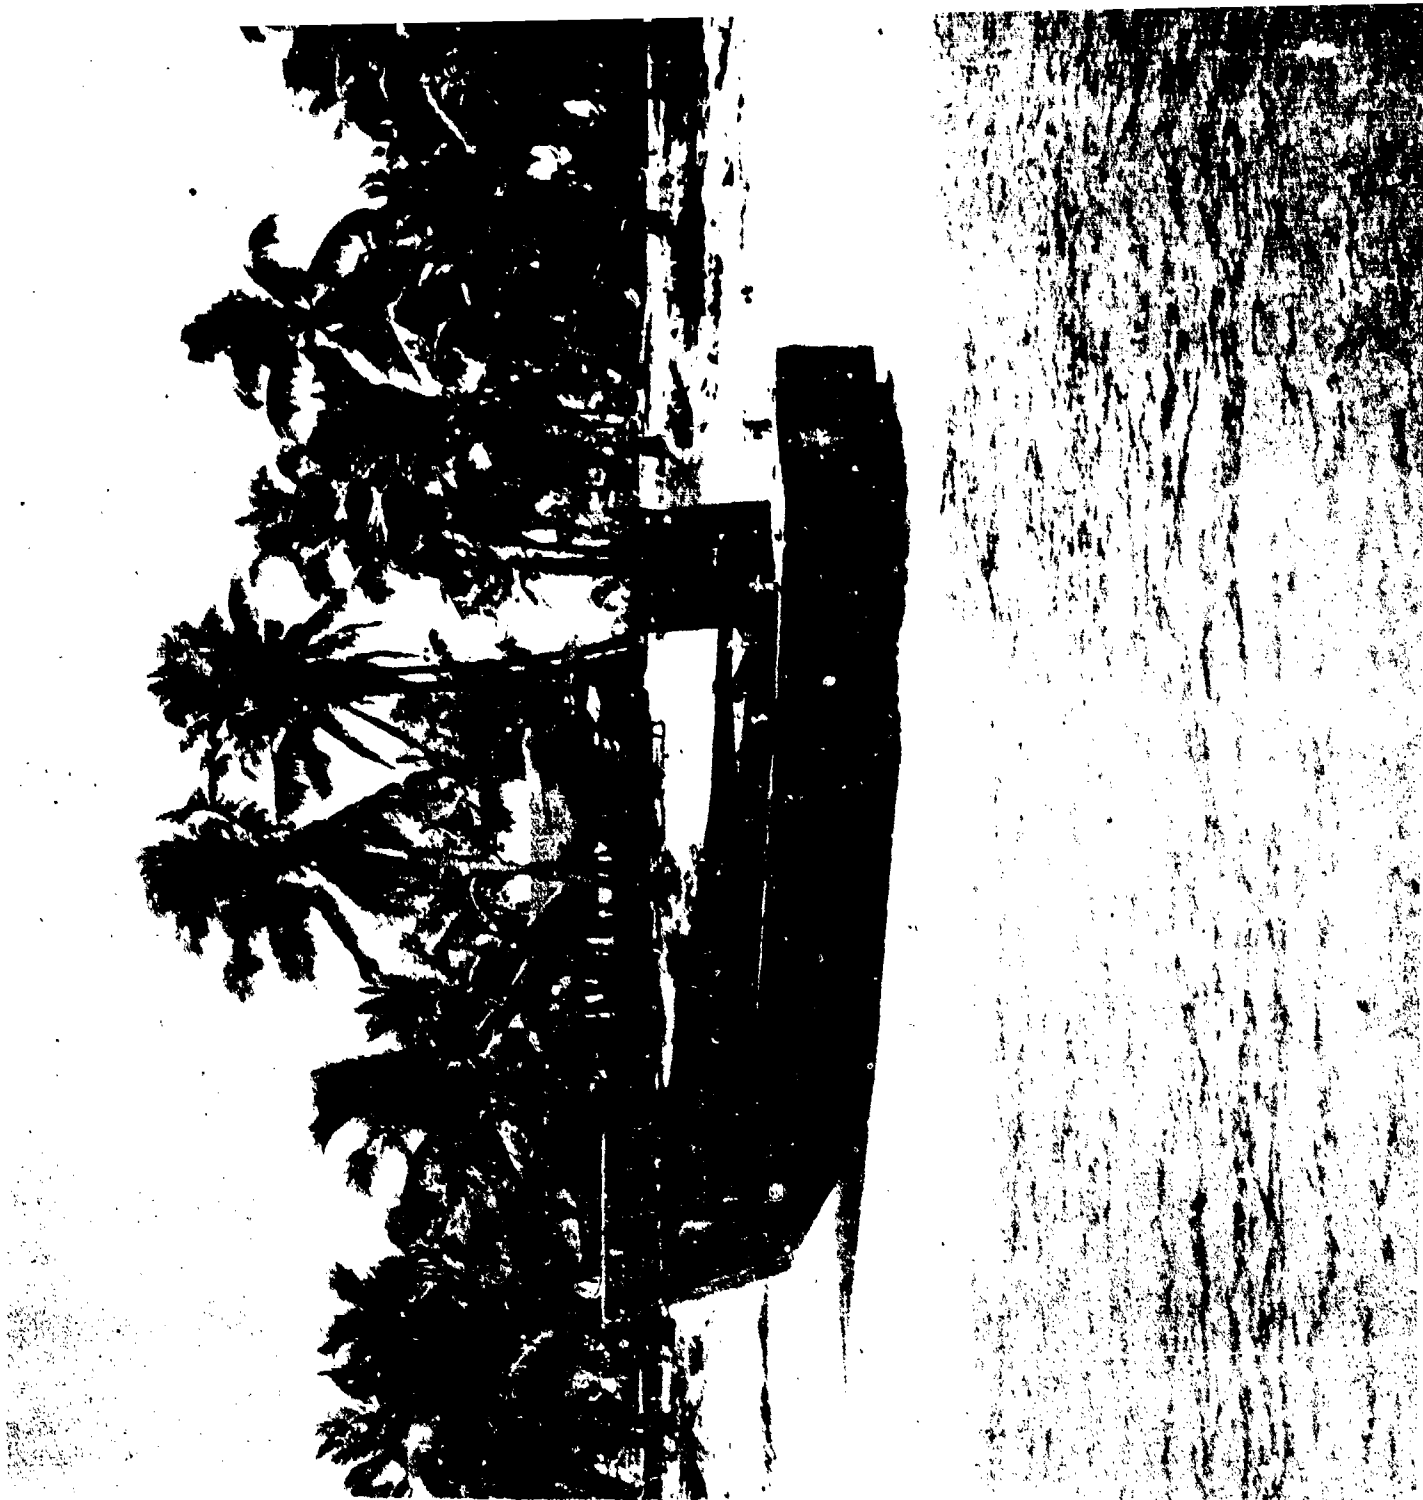
AB-CR-227-287-37. LCM-1 after Test B.

This craft moved about 20 feet along the beach from its location before the test. (Photograph 287-37, page 32).

No apparent damage occurred as a result of the test. At the time of inspection, hatches to the engine room and after compartment were open. As a result of wave action and heavy rains, there was two feet of water in the vehicle space, engine room, and after compartments.

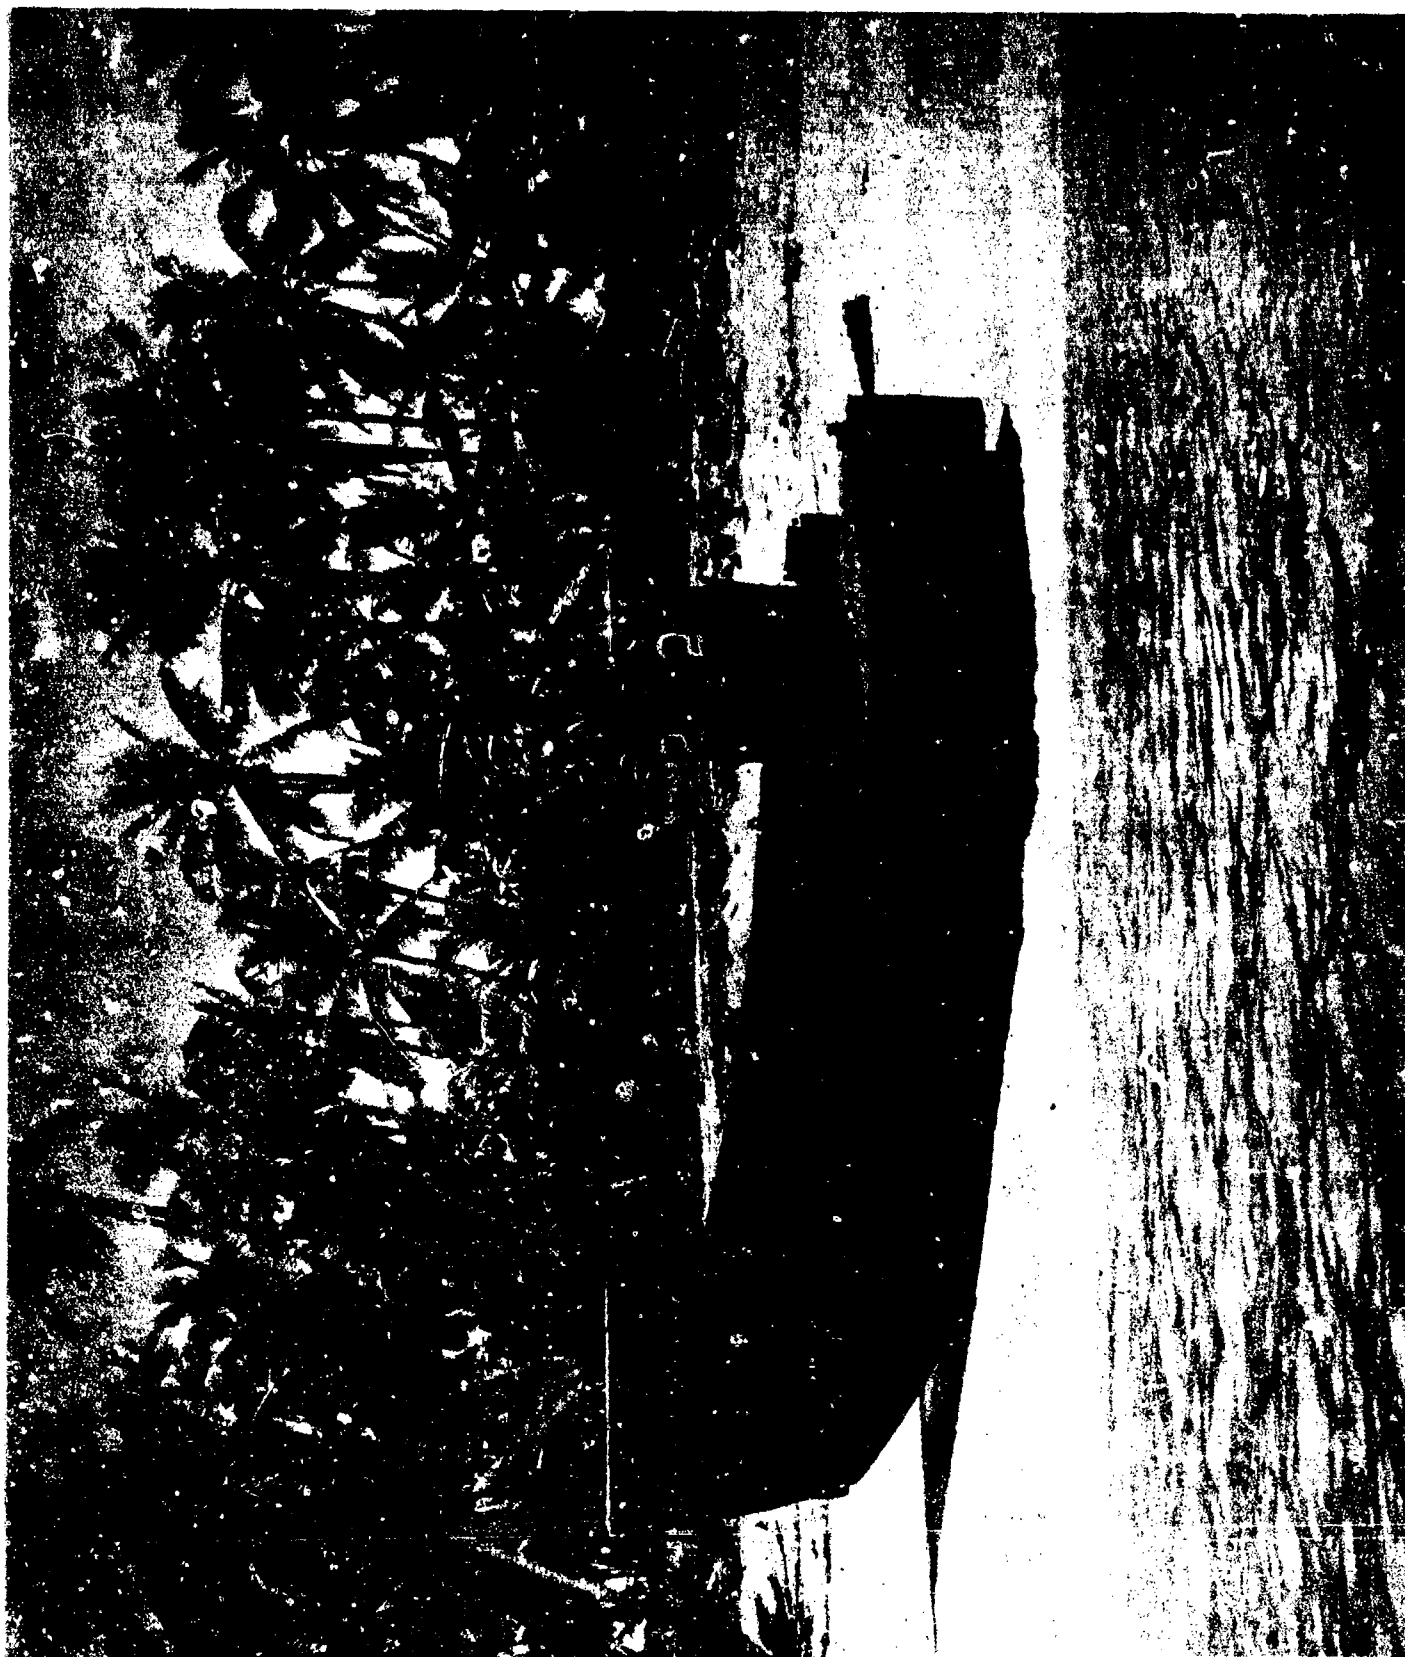
AB-CR-227-287-48. LCM-2 after Test B.

When inspected after the test this craft was on the beach in approximately her original position. (Photograph 287-48, page 33). The craft was apparently undamaged as a result of test B.

Hatches to the engine room and after compartment were open. The after part of the vehicle space contained eight inches of water, the engine room, 18 inches, and the after compartment, 12 inches.

A hole 10" x 6" was stove in the starboard side, two feet above the bottom at the after quarter point. A hole 3" x 1-1/2" was punched through the port shell eight inches above the bottom and six feet from the bow. It is believed that these holes existed prior to the test and were caused by contact with coral or with other craft.
